The Vapor Trail

Meet moisture vapor
transmission problems head-
on in the specifications.

By Rick Gregory

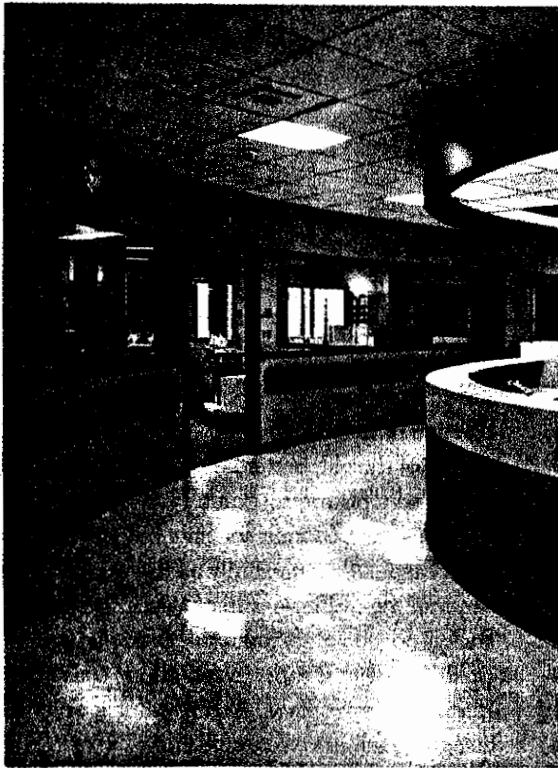
Albert Kahn Assoc., Detroit. Photo: Daniel Barush

Vinyl composition tile prevents moisture moving up through the slab from escaping.
